Water Distribution Leak Detection & How it Helps During Drought Conditions

Water Monitoring Training
November 17, 2016

Dave Hiscock
Regional Superintendent, Water Services Department

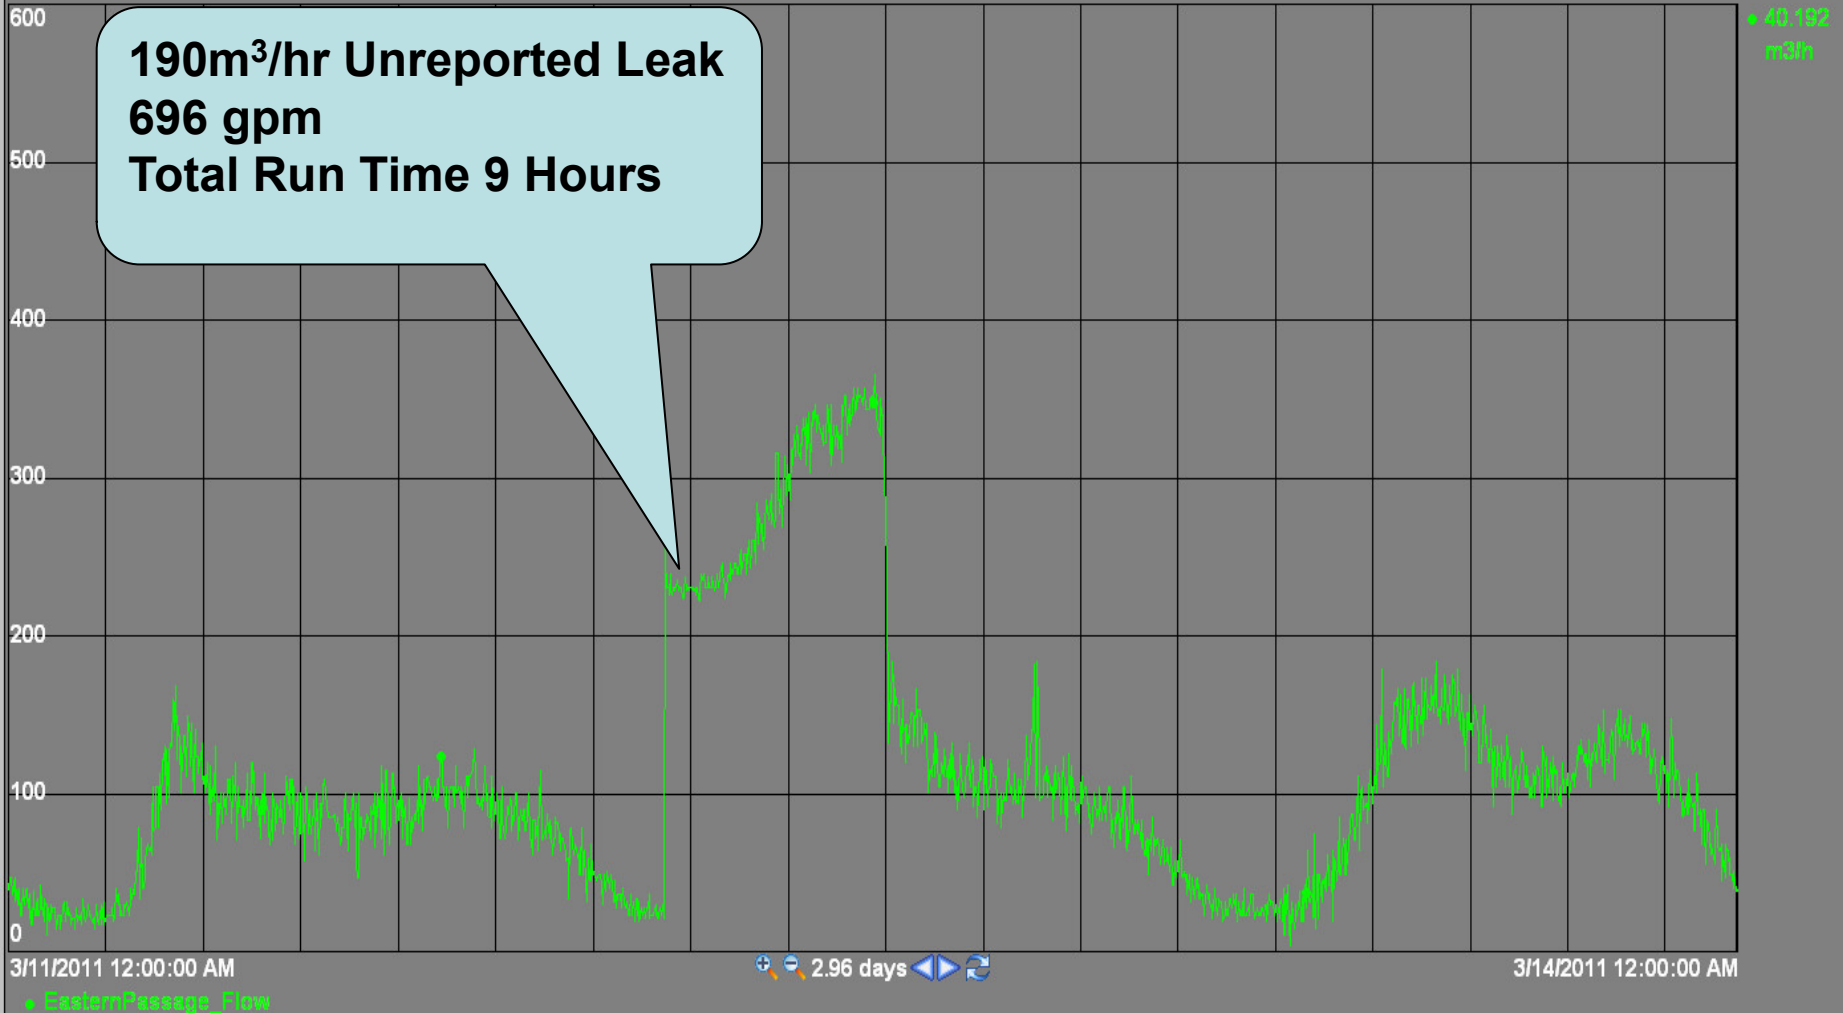
▶ Eastern Passage Water Break

Eastern Passage Flow

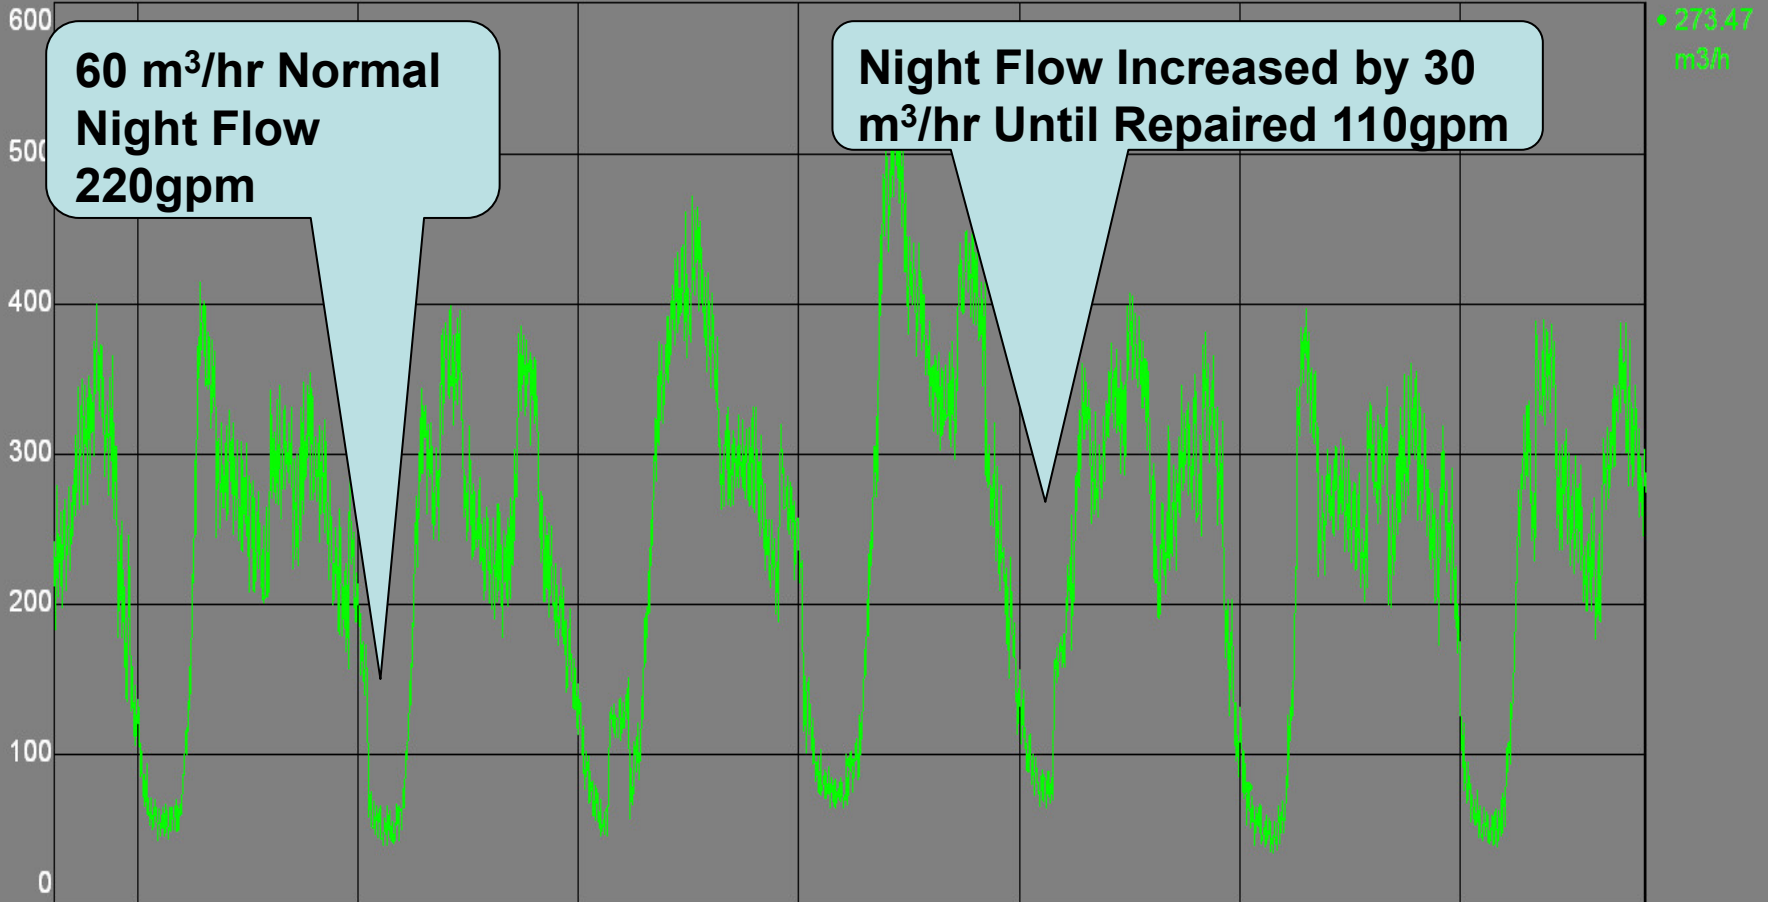
Dartmouth East High Water Break Leak Identified on 24" Water Meter

**60 m³/hr Normal
Night Flow
220gpm**

**Night Flow Increased by 30
m³/hr Until Repaired 110gpm**

7.21 days

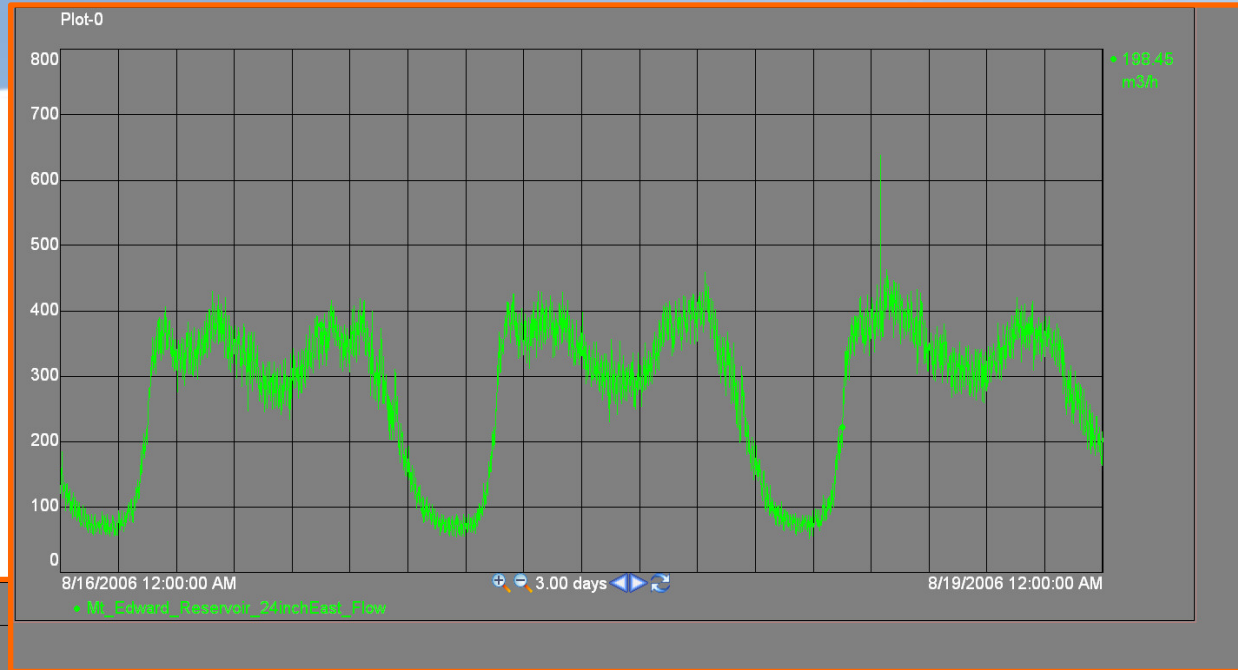
How Effective Are Your Active Leak Detection Efforts

Population 20,000 People

2006 Minimum Night Flow 180 gpm

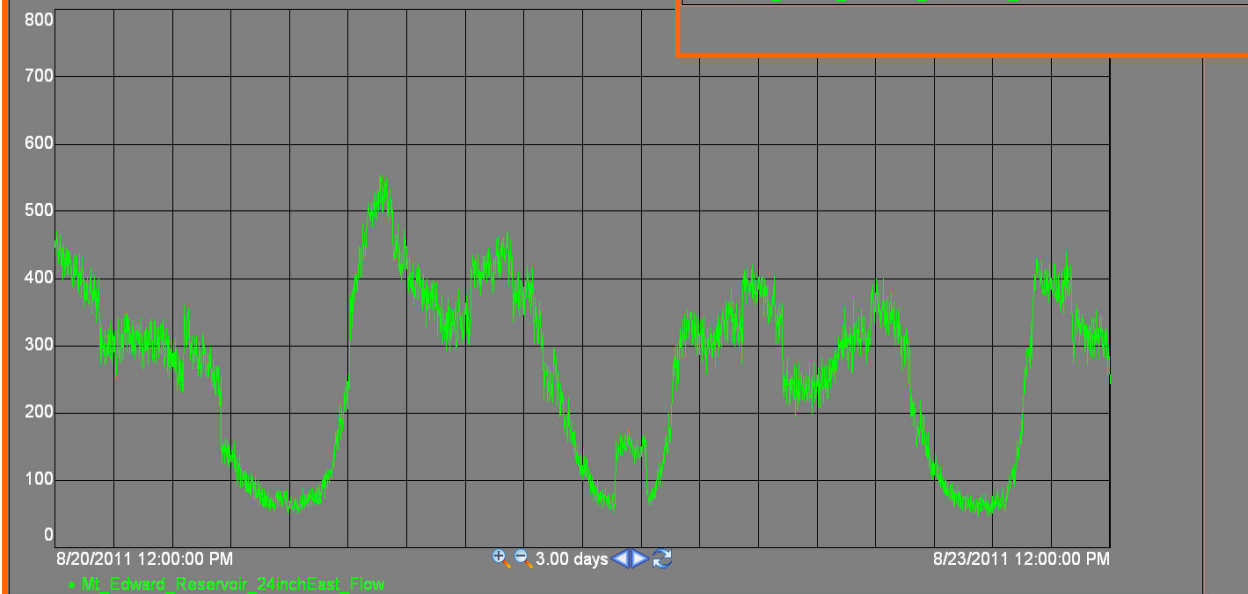
Mt Edward 24 East

2011 Minimum Night Flow 180 gpm

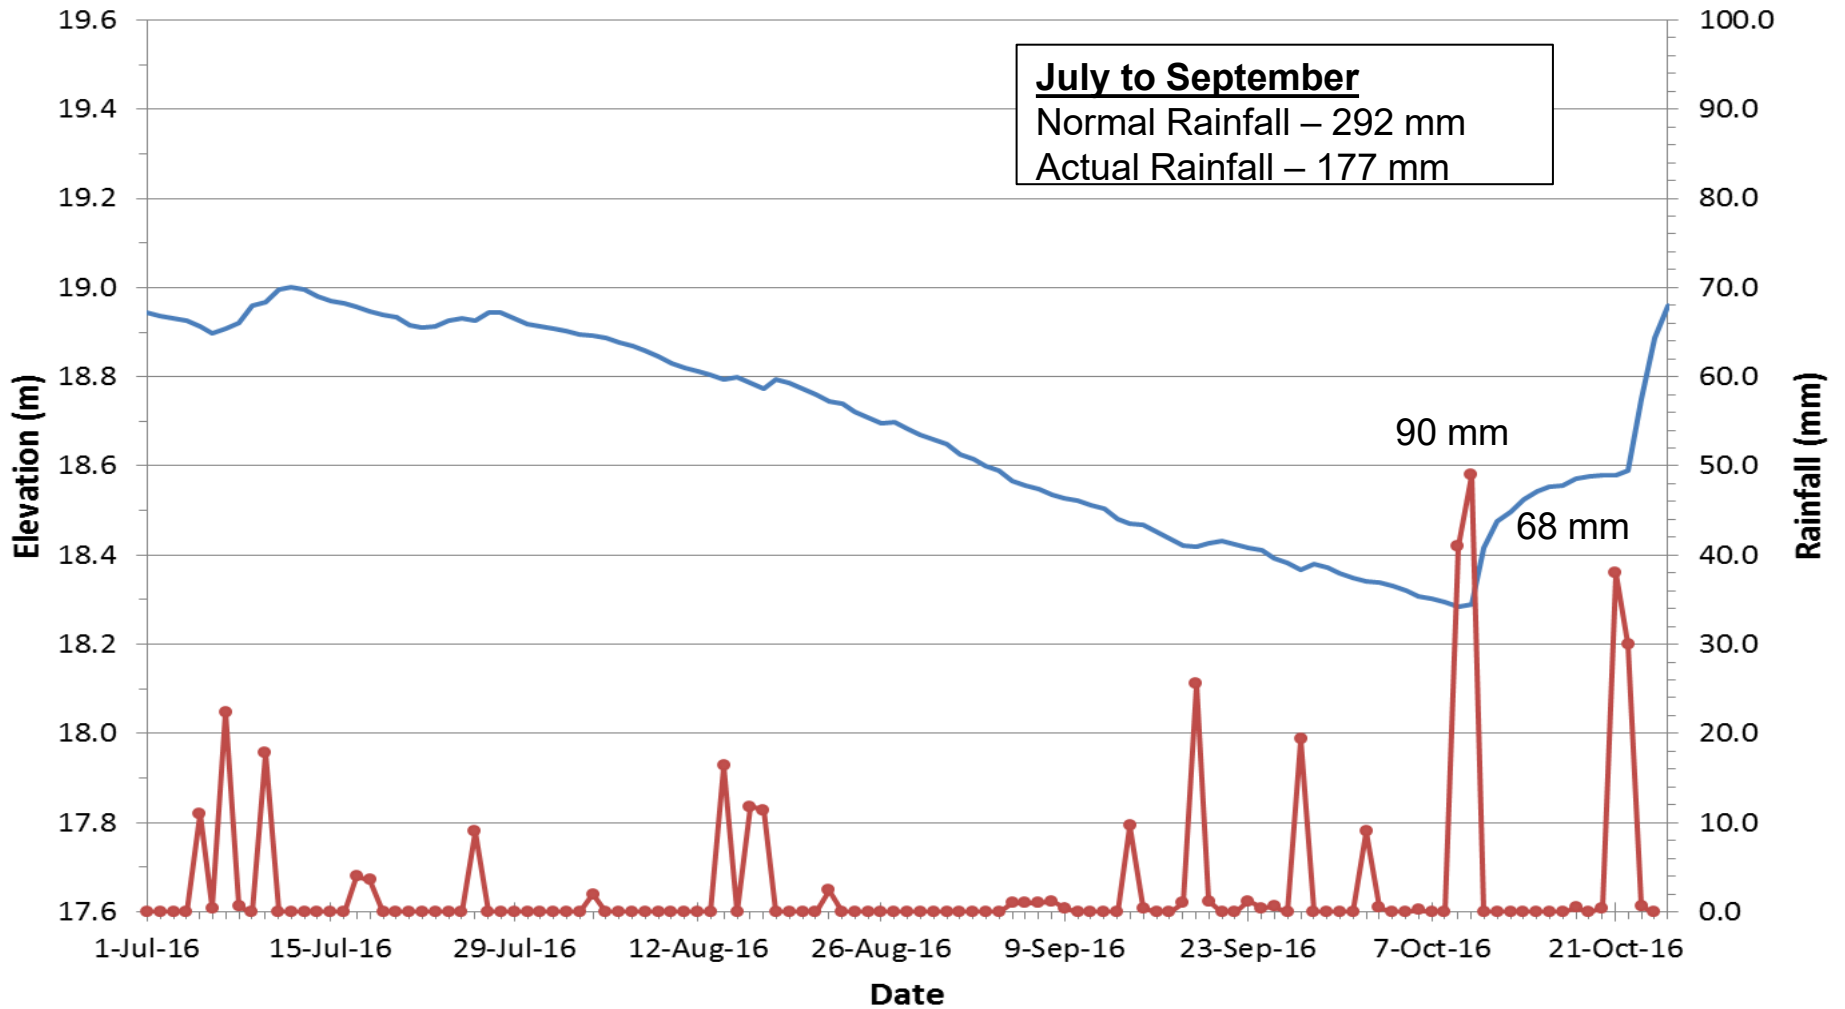
Lake Major Water Level

— Water Elevation —●— Rainfall

July 12 – 19.00 m

Historic low water level
